Joint Environmental Management of the River Tana - WP2 Migration barriers

Joint summary report (2017-2019)

REPORTS 10 | 2020

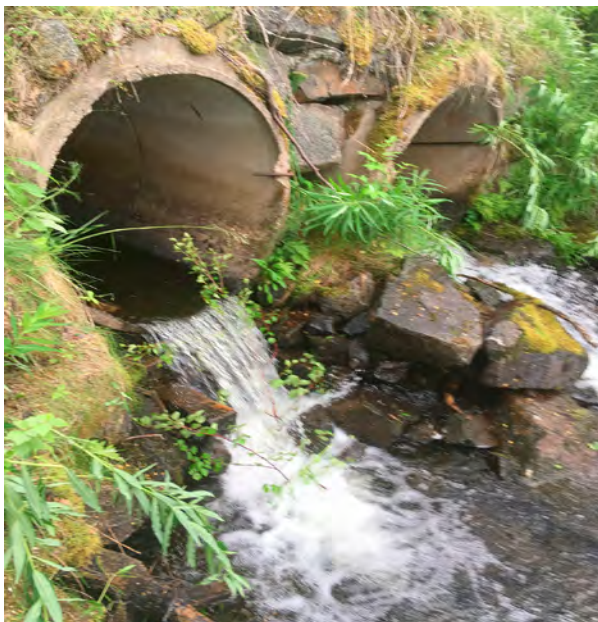
From restored sites after the year 2000, road culvert in Vuolit Boratbokcájohka I (lower branch) was still a migration barrier. At the survey done by the Center for Economic Development, Transport and the Environment (ELY) in summer of 2018, the estimated drop at road culverts in Vuolit Boratbokcájohka was around 40 cm from the pipe outlet to the surface of the channels water. Another measurement done by Natural Recourses Institute Finland (LUKE) later in the year 2018 the drop was estimated as 60 – 70 cm.

Figure 2. Vuolit Boratbokcájohka before restoration.

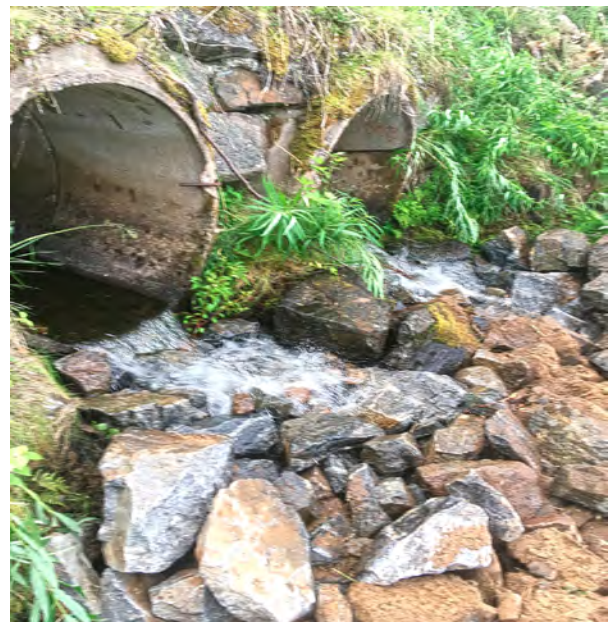
Figure 3. Vuolit Boratbokcájohka after restoration.

The restoration work started in July 2019. Matti Kylmäniemi from Natural Recourses Institute Finland advised and supervised the installation of the blasted stones (quarry). He knew that during the spring flood, the water would completely fill the drums. The juveniles rise to the tributaries of the River Tana immediately after the spring flood. After the restoration, the threshold is 15 cm enabling the fish migration. Restoration of Vuolit Boratbokcájohka was done by Finnish infrastructure company Destia Oy 29.7 – 1.8.2019.

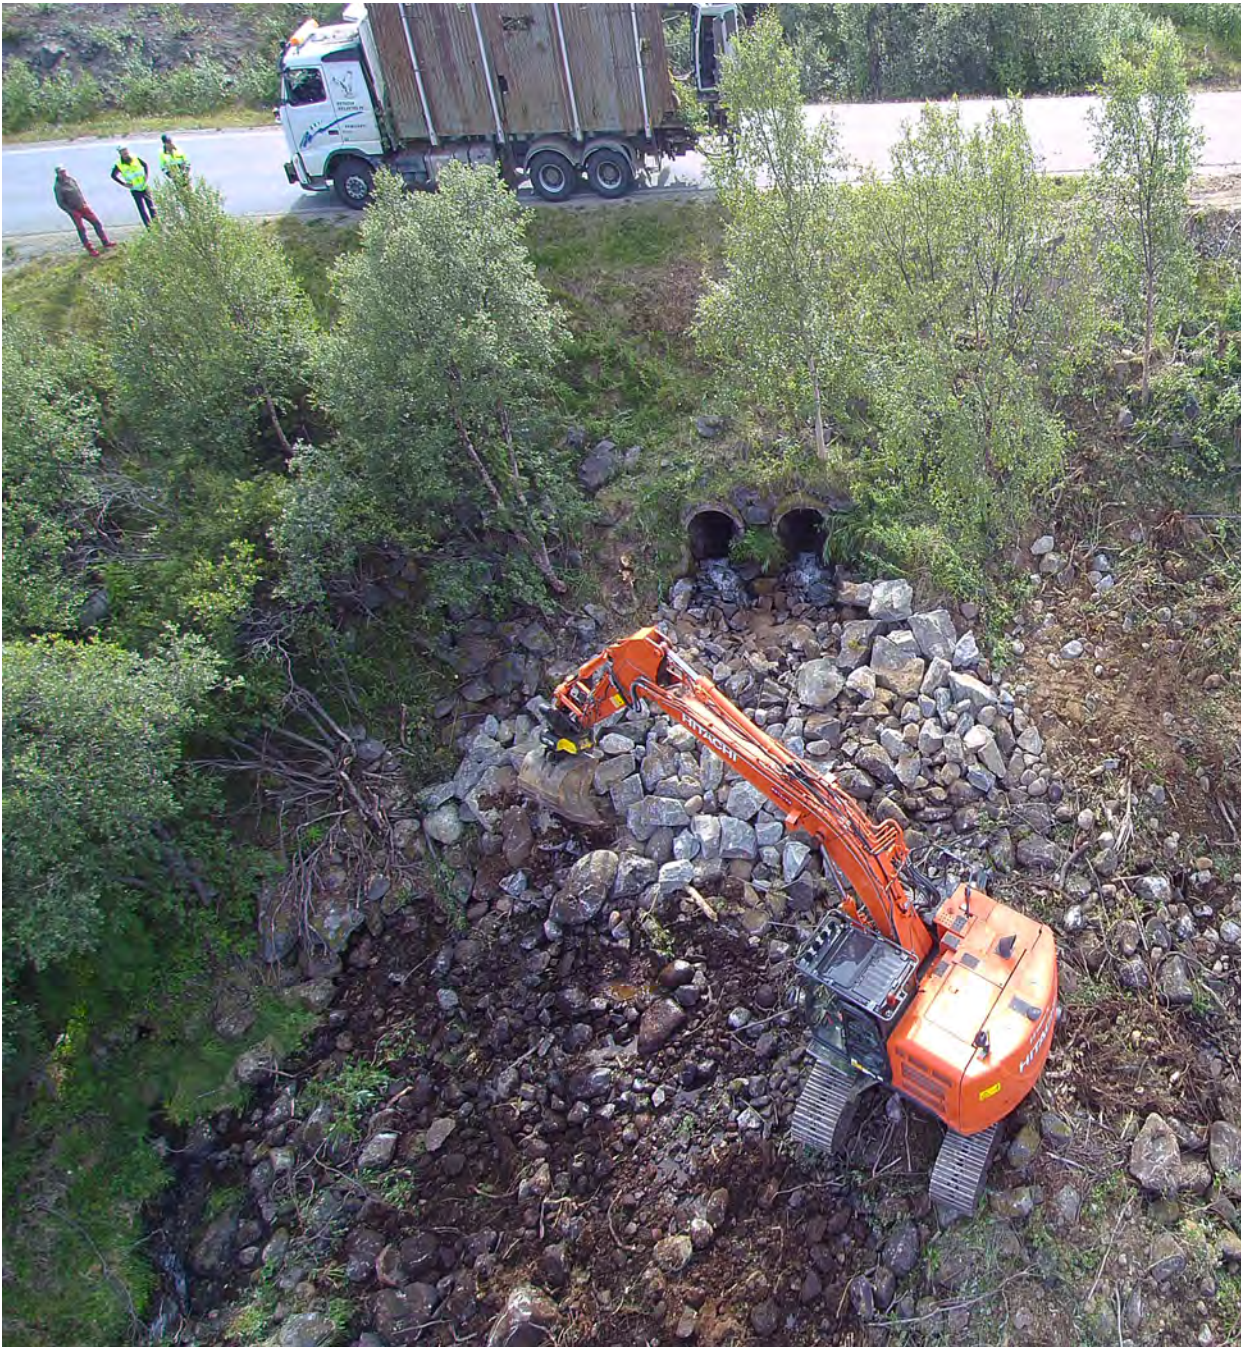
Figure 4. Vuolit Boratbokcájohka during restoration.

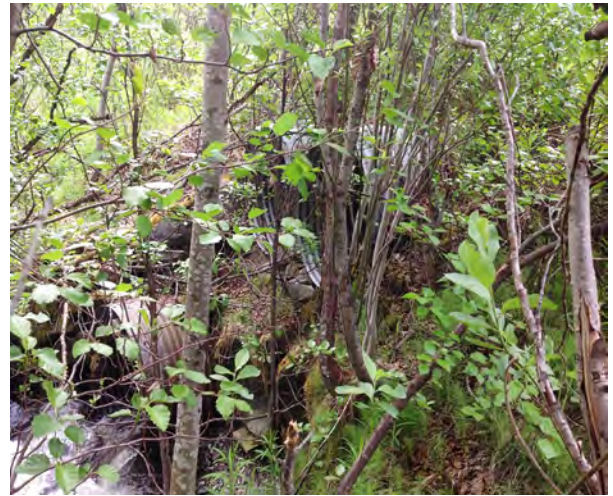
Vuohppejohka is a side- river that was surveyed in 2004 and re-surveyed in 2013 and 2014. Two sites had barriers for migrating fish on the stretch from the main river to lake Vuolit Vuohppejávri. The lower site consisted of a road crossing on a private road with 5 culverts creating a barrier (fig. 5). The drop from the outlet of the lowest culvert to the water surface was 20 cm. On the main road, another site with one culvert created a drop of 75 cm (fig.7). This culvert was restored in 2019 by the Public Roads Administration and Finnmark county (fig 8). The culverts on the private road have not been removed. However, in 2019, as a part of this project as threshold was built downstream the culverts to increase the water lever and enable fish passings (fig.6).

Figure 5. Culverts on the private road at Vuohppejohka.

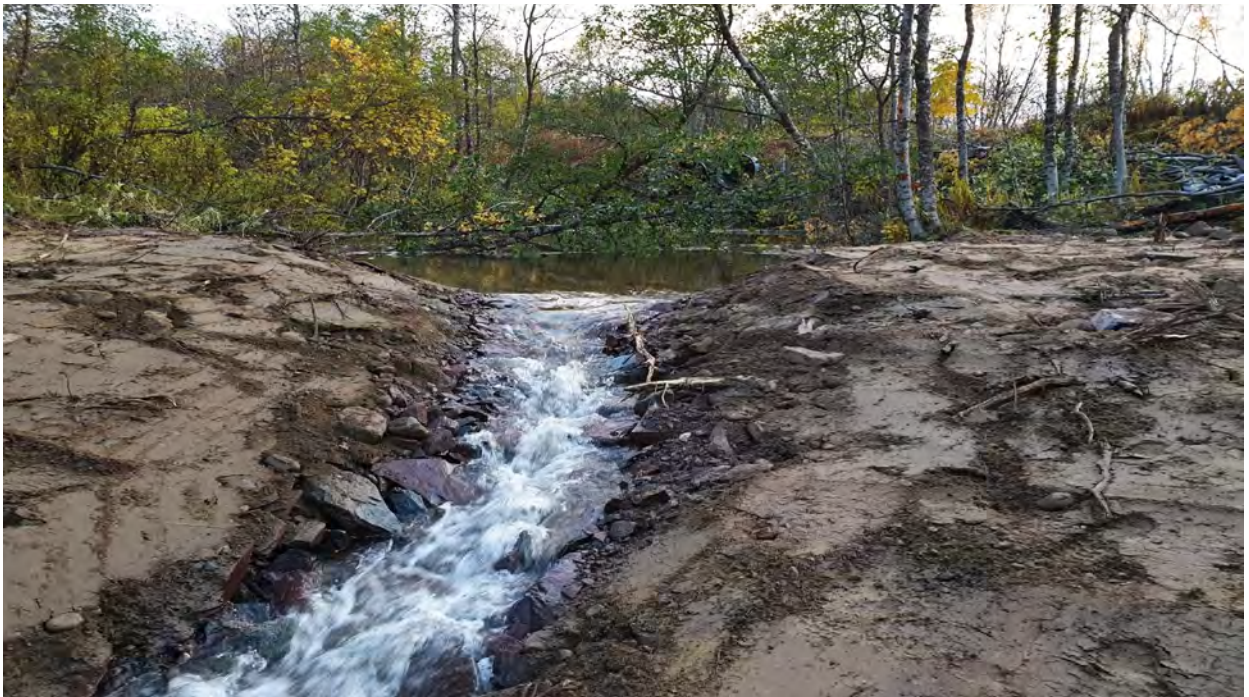
Figure 6. The threshold built to increase the water level Vuohppejohka (private road).

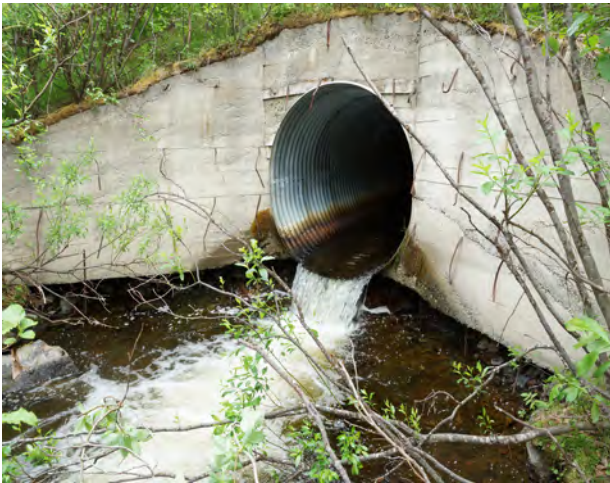
Figure 7. Vuohppejohka before the restoration (main road).

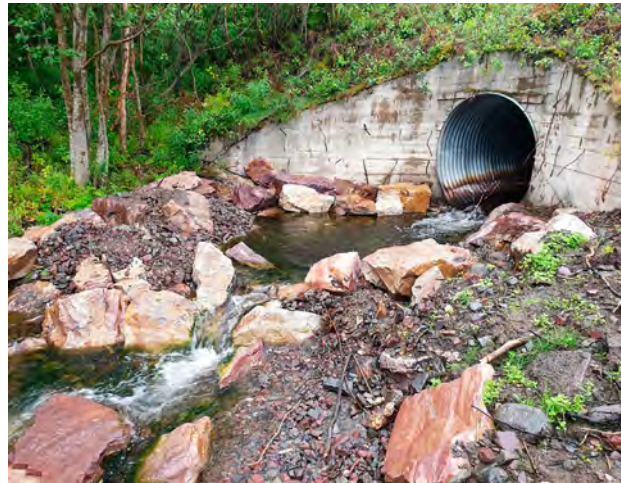
Figure 8. Vuohppejohka after the restoration (main road)..

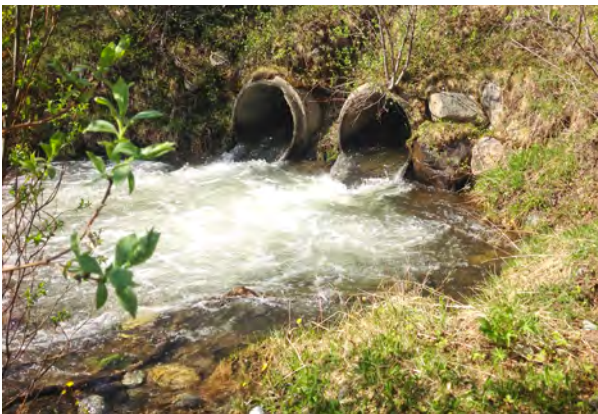
1980's with two culverts creating a barrier for migrating fish (drop of 50 cm and high water velocity) (fig 8). Electrofishing in 2004 and later in 2017 documented salmon parr below the culvert, but only a few individuals upstream the road crossing. The two culverts were replaced in 2019 as a part of our Interreg project with a new and larger culvert. A threshold was also created above the road crossing to lower the height difference and decrease the water velocity (see photoes 9,10 and 11).

Figure 9. Lišmmajohka before the restoration (Photo: NVE nord).

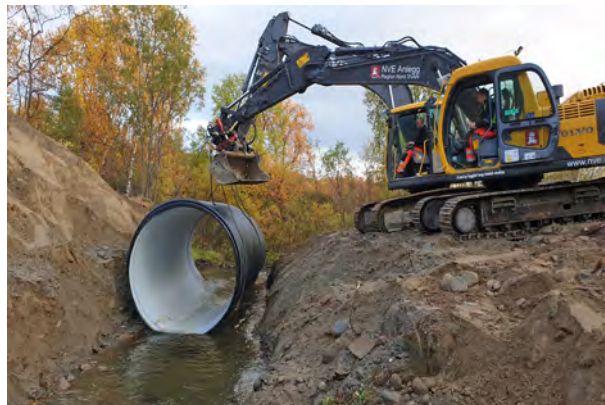
Figure 10. Figure 10 Lišmmajohka during the restoration (Photo:NVE nord).

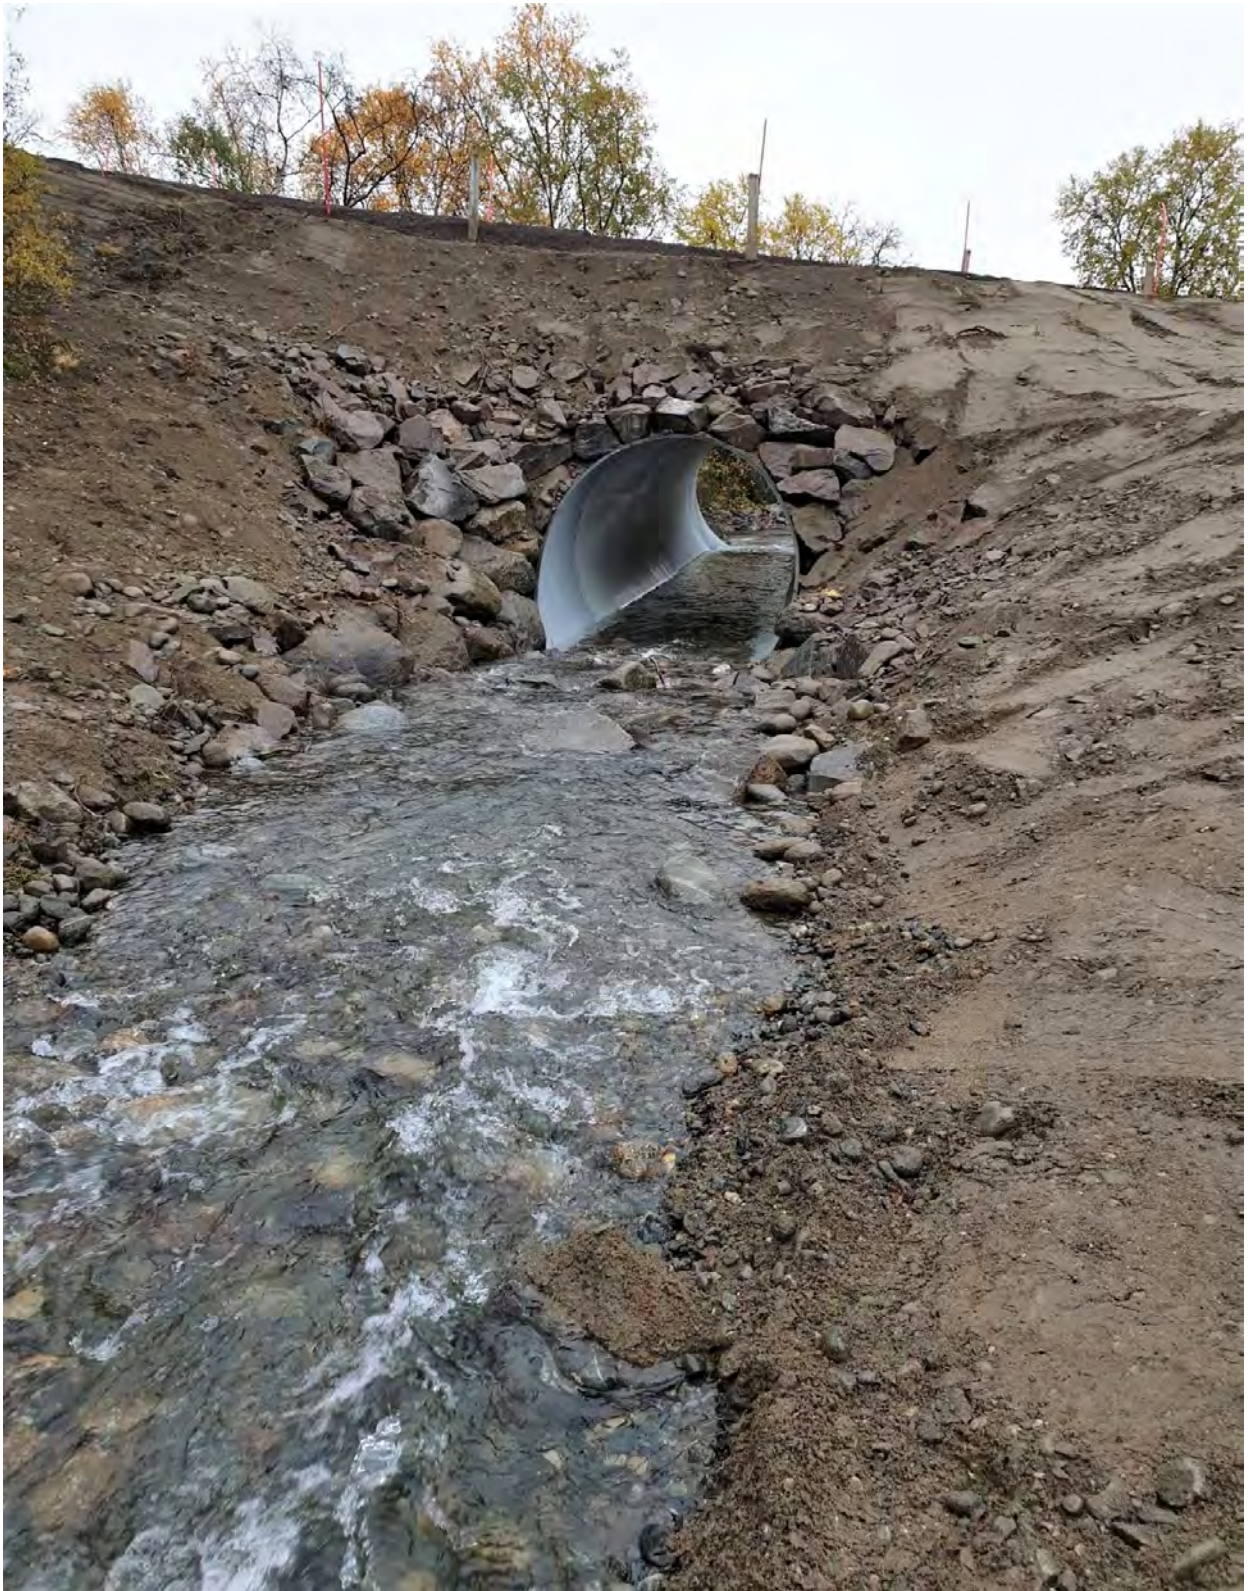
Figure 11. Lišmmajohka after the restoration (Photo: NVE nord).
