Joint Environmental Management of the River Tana - WP2 Migration barriers

Joint summary report (2017-2019)

REPORTS 10 | 2020

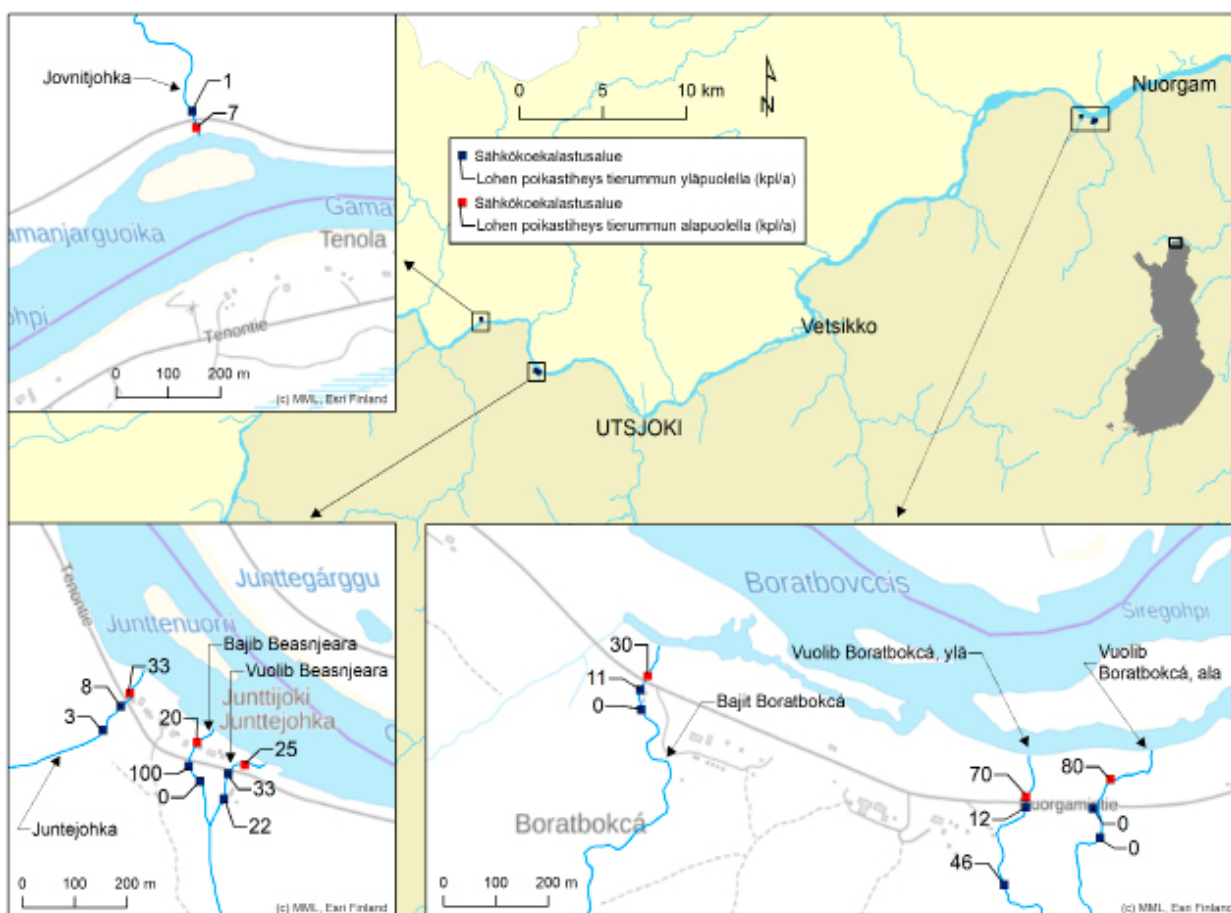
Figure 1. Streams and sites electrofished in 2018 by the Natural Resources Institute Finland (Luke). Numbers at sampling sites denote juvenile salmon densities (fish per 100 m²); sites marked in red are downstream the road culvert; sites marked in dark blue are upstream.

According to the results of the study done by Natural Resources Institute Finland, the culverts seemed to be supporting conductivity in the streams and in most cases the juvenile salmon densities were higher on both sides of the culverts than during the earlier surveys (Figure 1; see also Erkinaro et al. 2017). However, at Vuolib Boratbokcá the vertical drop below the culvert had increased in height to 60 cm and at least under the late summer flow conditions, the culvert was severe hindrance, if not total barrier to fish migration from downstream. Vuolit Boratbokcá (lower branch) was then restored as a part of this project in July 2019 (more details of the restoration on page 9).
